**Subject:** Removal Assessment Report  
**Tanglefoot Lane Site, Bettendorf, Iowa**  
**EPA SEMS Identification No. IAN000703123**  
**U.S. EPA Region 7, START 5, Contract No. [REDACTED]**  
**Task Order No. 21F0035**  
**Task Monitor: Andrew Gieseke, EPA On-Scene Coordinator**

**REMOVAL ASSESSMENT REPORT  
TANGLEFOOT LANE SITE  
BETTENDORF, IOWA**

**EPA SEMS ID – IAN000703123**

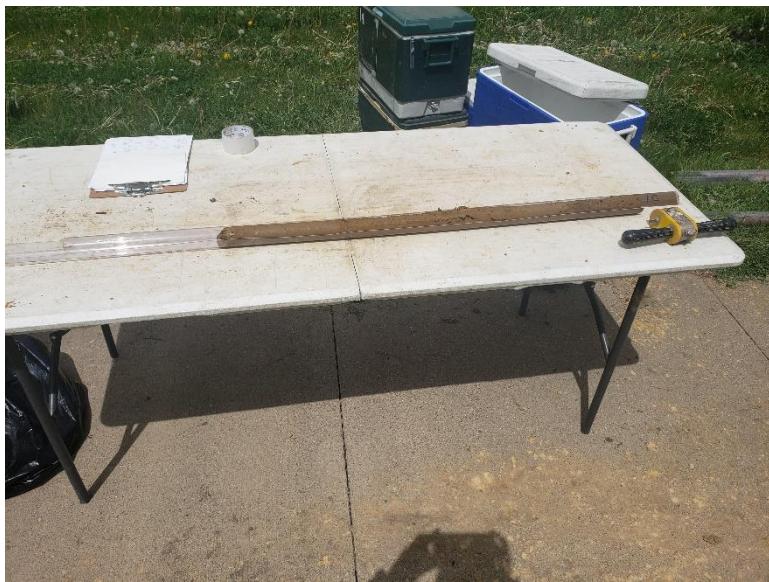
TETRA TECH PROJECT NO. 103X903021F0035	DESCRIPTION	This photograph shows DPT-9 soil core from 5-10 feet bgs. Sample collected within 9-10 feet bgs identified as 8811-36.	36
Direction: N/A	CLIENT	U.S. Environmental Protection Agency Region 7	Date
	PHOTOGRAPHER	Tim Barbeau	5/4/2021

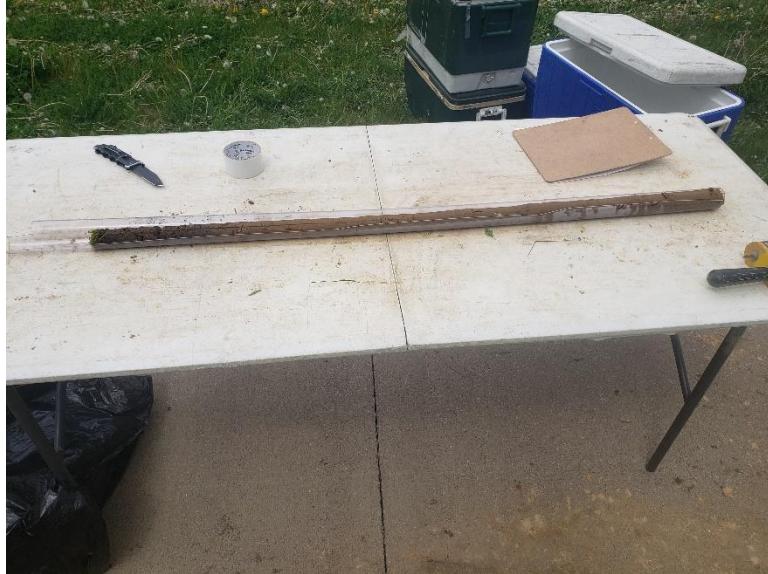
TETRA TECH PROJECT NO. 103X903021F0035	DESCRIPTION	This photograph shows DPT-5 soil core from 0-5 bgs. Sample collected within 4-5 feet bgs identified as 8811-37.	37
Direction: N/A	CLIENT	U.S. Environmental Protection Agency Region 7	Date
	PHOTOGRAPHER	Tim Barbeau	5/4/2021

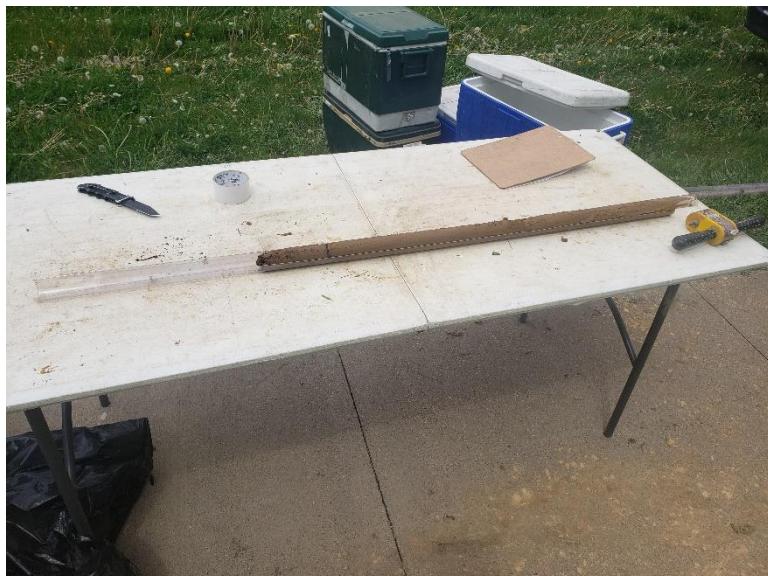
TETRA TECH PROJECT NO. 103X903021F0035	DESCRIPTION	This photograph shows DPT-5 soil core from 5-10 feet bgs. Sample collected within 9-10 feet bgs identified as 8811-38.	38
Direction: N/A	CLIENT	U.S. Environmental Protection Agency Region 7	Date
	PHOTOGRAPHER	Tim Barbeau	5/4/2021

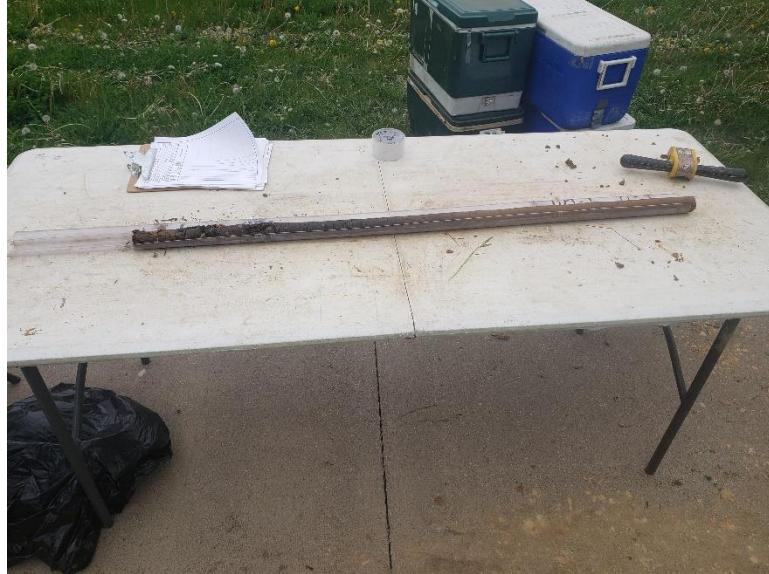
TETRA TECH PROJECT NO. 103X903021F0035	DESCRIPTION	This photograph shows DPT-1 soil core from 0-5 bgs. Sample collected within 4-5 feet bgs identified as 8811-39.	39
Direction: N/A	CLIENT	U.S. Environmental Protection Agency Region 7	Date
	PHOTOGRAPHER	Tim Barbeau	5/4/2021

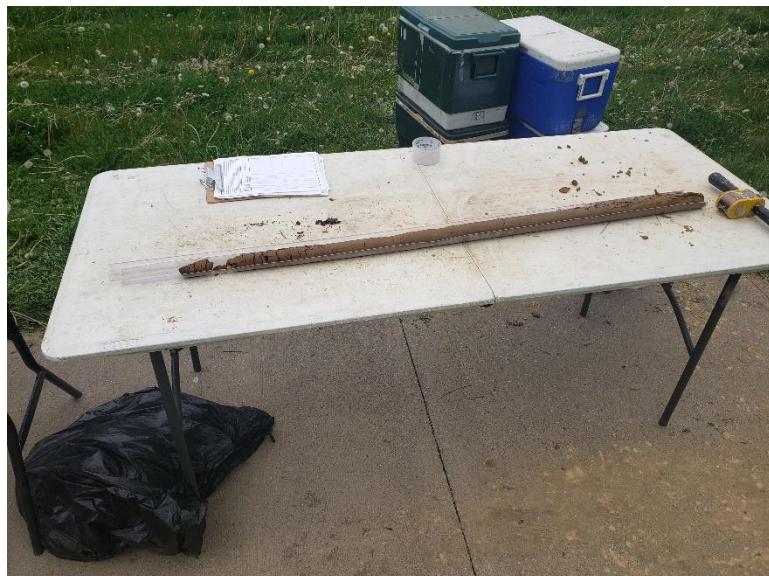
TETRA TECH PROJECT NO. 103X903021F0035	DESCRIPTION	This photograph shows DPT-1 soil core from 5-10 feet bgs. Sample collected within 9-10 feet bgs identified as 8811-40.	40
Direction: N/A	CLIENT	U.S. Environmental Protection Agency Region 7	Date
	PHOTOGRAPHER	Tim Barbeau	5/4/2021
